CASE STUDY: QUALITY ISSUES LARGE TIRE STAGING/RESTING PLATE

GENERAL DESCRIPTION: 72”, 14,000 pound staging/resting plate.

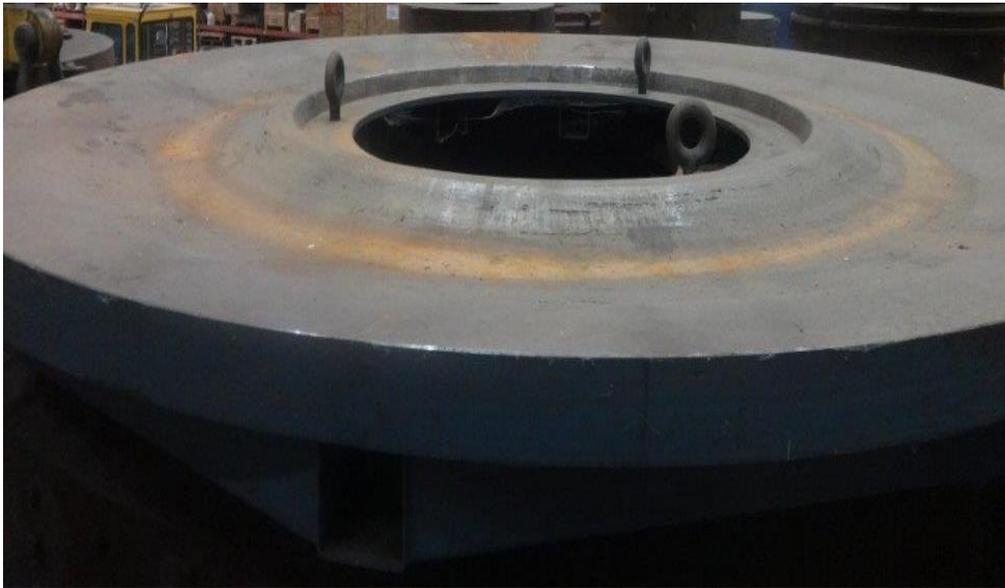
QUALITY PROBLEM – TIRE STAGING/STORAGE PRIOR TO CURING: Following the tires being released from the bladder rings, 14,000 lb., 72” tires are rested on cast iron plates prior to being moved for heat molding and storage.

These “green” (non-molded, non-cured) tires would stick to the plates causing damage to the tire. Often the sticking problem was so severe that when lifting the 14,000 pound tire, it would also lift the 15,000 pound iron stand off the ground with it. This required the use of significant mechanical force to separate the tires from the stands. Not only did this result in quality issues, and lost production; it created unacceptable safety issues.

SOLUTION: Dyna-Tek’s mold sealer and release coating system. The Staging/Resting Plate was lightly mechanically etched so as to remove impurities, and clean the metal surface. Upon completion of this step, the surface was cleaned with an approved solvent so as to remove any remaining impurities.

The metal surface received Dyna-Tek’s DT-400 Base Sealer designed to permeate the surface and seal the pores of the metal surface; including the entire outer surface, and internal channels. This process is a hand applied and allowed to ambient cure for a period of 24 hours.

With the Base Sealer in place, Dyna-Tek’s DT-6000 Mold Release coating is applied. Unlike the sealer, the top coat can be applied either by wiping, or with conventional spray equipment. Upon completion, the top coat is allowed to cure for 4-5 days; although the coating is dry to the touch in 20 min.
